## Town of Williamsburg, MA

Helen E. James School & Town Office Building Repurposing Study

June 19, 2015

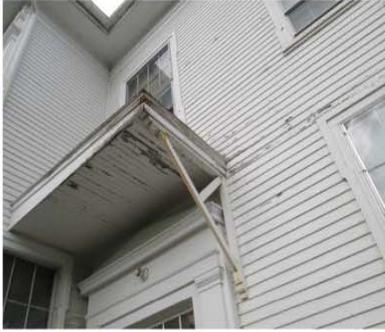
Damaged canopy at South entrance

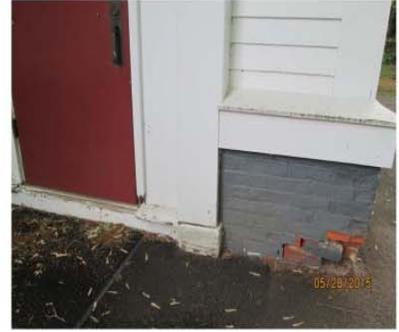
Damage at Northwest corner

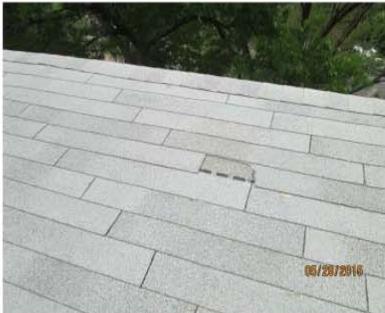
Missing asphalt shingle

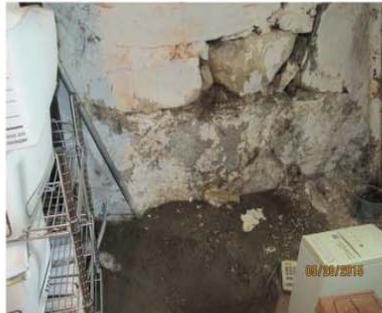
Water intrusion in evidence storm

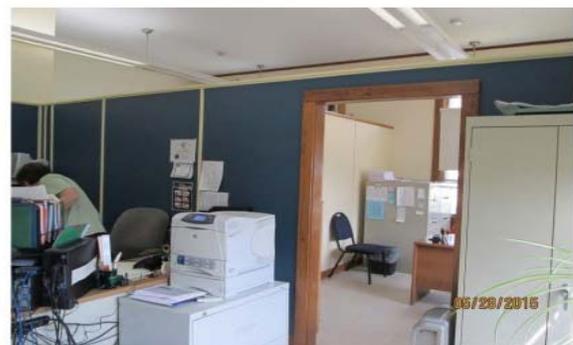
Partial ht ptns in collector's office

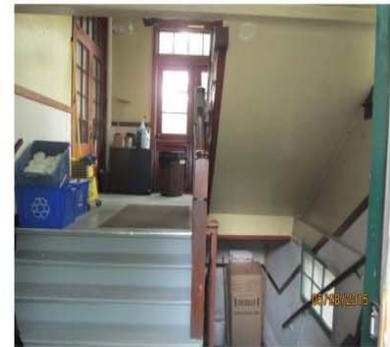
The separation of the basement from the upper floors should also be considered. Fire separations at connections to the basement in the stairways prevent the spread of fire and smoke from the storage

West stair from basement

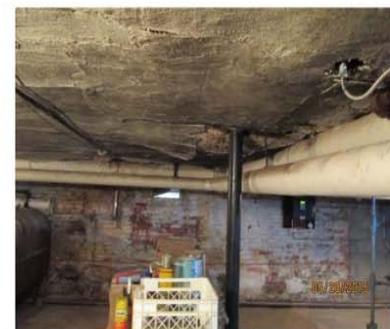
Collapsing plaster ceiling in boiler room

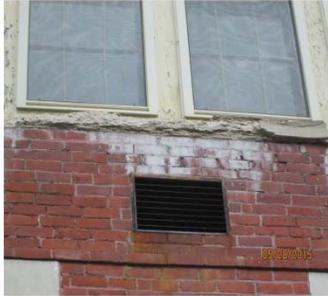
Deteriorated precast sill East elevation

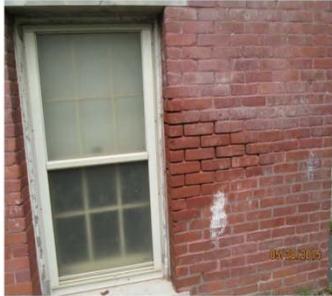
Open masonry joints East elevation

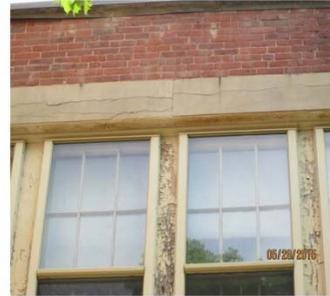
Damaged precast lintel East of new addition

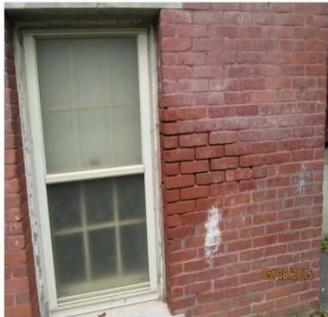
Open masonry joints east elevation

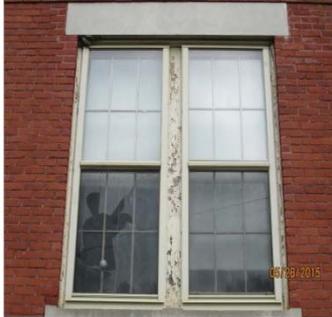
Broken window East elevation

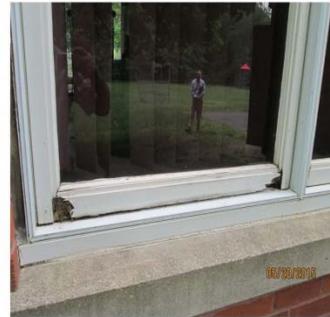
Rotten wood window at new addition

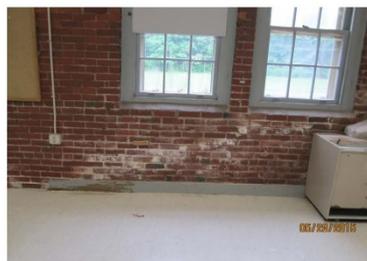
Efflorescence under windows in preschool room

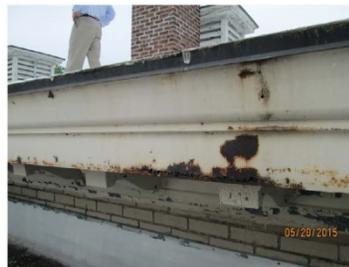
Rusted metal cornice

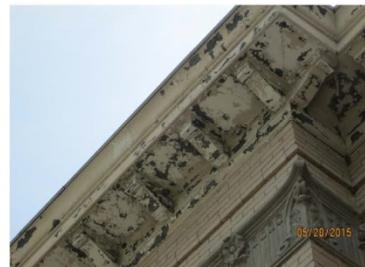
Peeling metal cornice on West

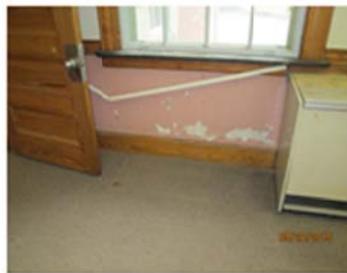
Classroom 2 peeling paint at window

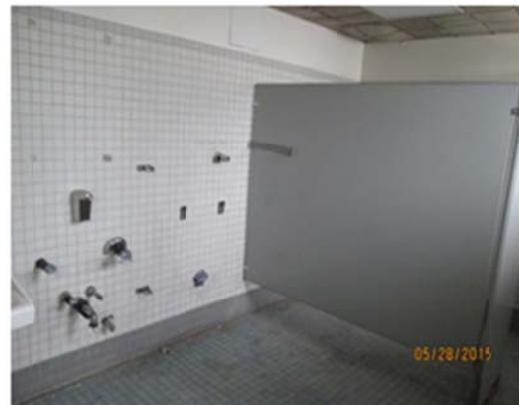
Men's room stained ceiling fixtures removed

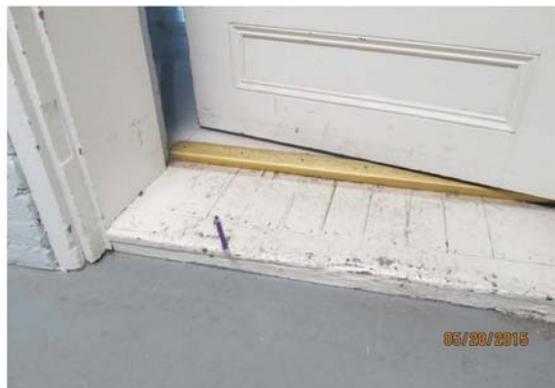
Step at door to pre-school room

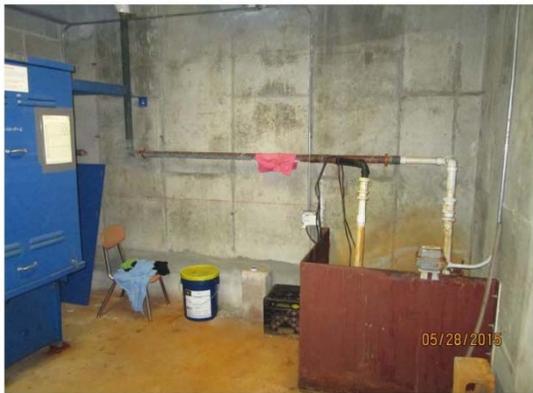
The elevator mechanical equipment room (MER) has a sump pit and sump pump that receives a significant amount of water from a foundation drain. Although currently functional this condition may be revised in a renovation to prevent storm water from entering the building requiring pumping to remove it.

Elevator machine room water pump

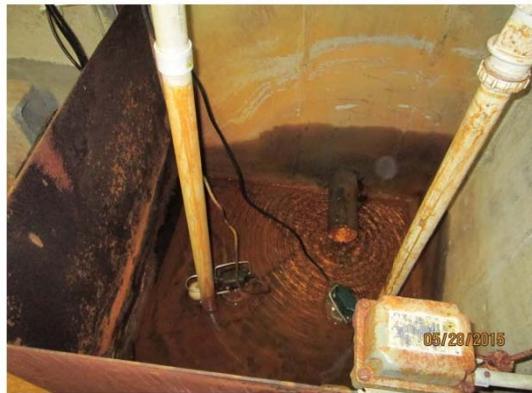
Elevator machine room water pump pit

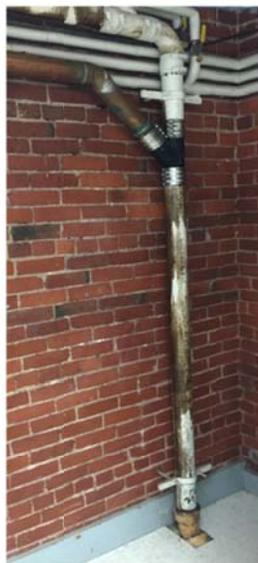
Repaired Sanitary Pipe
