## Town of Williamsburg, MA

Helen E. James School & Town Office Building Repurposing Study

June 19, 2015

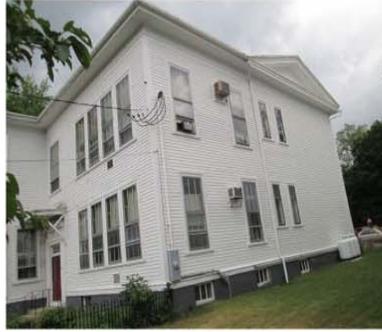
Southeast corner elevations

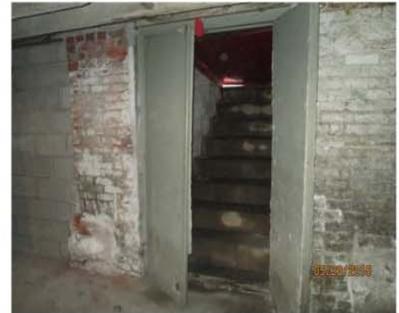
As with all wood exteriors, the clapboard, flush tongue and groove siding, as well as historic wood trim requires significant maintenance to ensure long life. Although the wood exterior of the building is in generally good condition, some areas require repair and repainting such as the south entrance canopy. The windows are generally large double hung wood sash with single glazing with storm windows. The windows are energy inefficient and need replacement. The roof and chimney have been recently repaired and replaced therefore in good condition although there are a couple missing asphalt shingles that require minor repair. Some exterior doors are in need of replacement such as those on the northwest corner and the basement stair in the bulkhead.

Stair and door to bulkhead

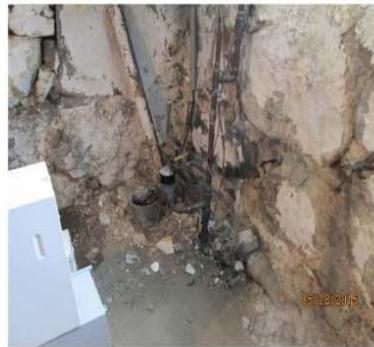
Water service in evidence storm

A  $\frac{3}{4}$  inch water service enters the front of the building from Main Street. The water piping is copper and appears to be in fair condition. The building sanitary piping is a combination of PVC and ABS plastic piping above grade and appears to be in good condition. A six inch PVC sanitary line exits the building from the northwest corner near the boiler pit. Domestic hot water is provided by a Rheem electric hot water heater with 80 gallons of storage. The domestic hot water heater is relatively new and in good condition.

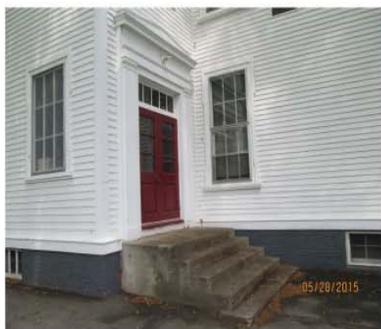
and mechanical spaces of the basement. Also devices blocking paths to the basement in the stairwells prevents anyone from mistakenly exiting down to the basement in an emergency. All stairs such as the exterior stair at the west and the stair to the auditorium stage must have handrails and any guardrails need to be 42 inches in height.

South exterior door of West stair

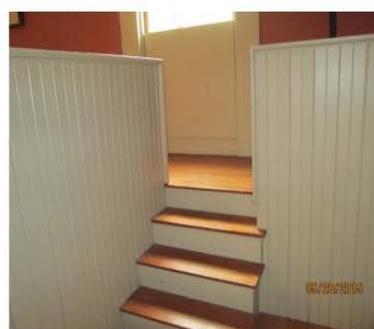
Stairs to stage

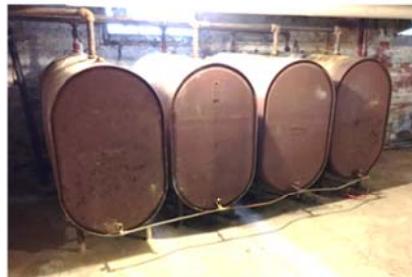
Oil Tanks

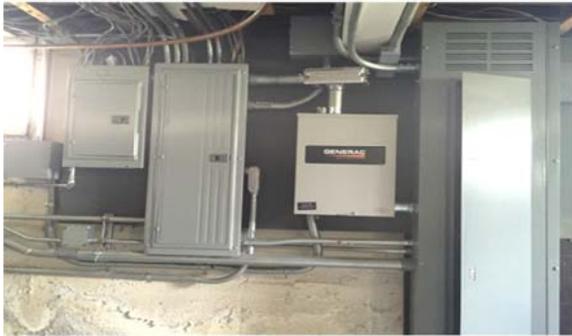
Main electric is provided by an overhead electric service from an electric pole on Main Street and enters the east side of the building. The main electric service is a 400 amp main three phase 120/208 volt and is located in the basement on the east wall. The main electric service, distribution panels and sub-panels are new and in excellent condition. The main distribution panel serves subpanels feeding the basement, first and second floor panels. While the electric service, main panels and feeders are new, there is old branch circuitry wiring throughout the building that serves lighting and electrical outlets. The general offices spaces have limited quantities of electrical outlets and an electrical upgrade of the branch circuit wiring will likely be required depending upon the future usage of the building. A 14 kW propane gas generator was installed in 20012/13 and serves limited life safety loads within the building.

Main Electric Panels

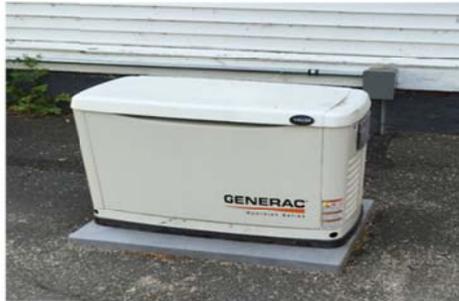
Emergency Generator

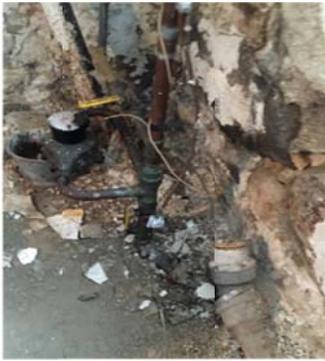
The building does not have an automatic sprinkler system or a fire protection standpipe. A new water and fire protection service will be required depending upon the future use of the building given the small size of the water service and lack of a water based fire protection system.

Water Service

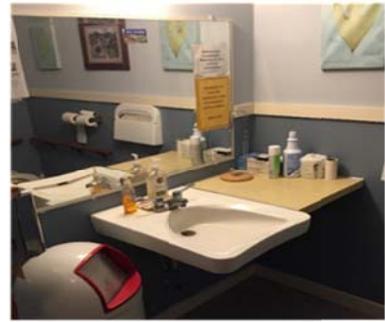
Although the toilet plumbing fixtures appear to be in fair to good condition, there exists only two single person toilet rooms in the building. The toilet room on the first floor is ADA compliant and services both genders. The toilet room on the second floor is also for both genders and is very small and not ADA compliant. Given the size of the building and its public occupancy the existing toilet fixture counts are inadequate and therefore additional toilet rooms need to be provided.

Lavatory

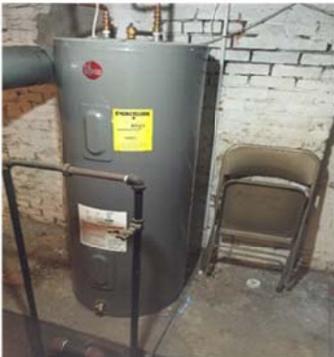
Hot Water Heater

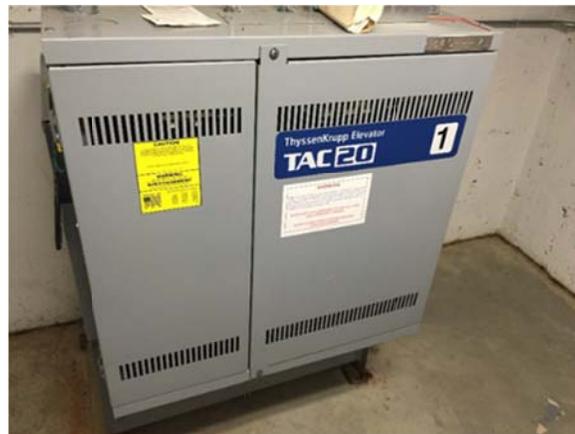
The elevator is manufactured by ThyssenKrupp, is hydraulically operated and was installed in 2003. The mechanical equipment and cab appear to be in excellent condition and the elevator is ADA accessible.

Hydraulic Elevator

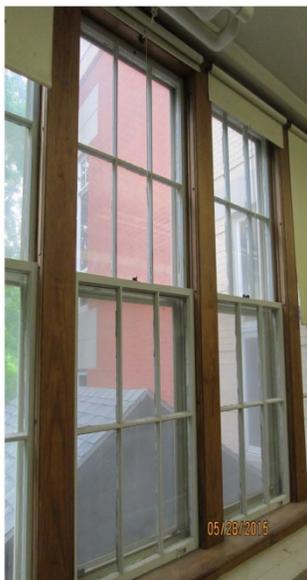
The exterior of the building although attractive in appearance is in significant need of repair and upgrade. In particular the masonry exterior of the building has many open mortar joints in the face brick and a number of the pre-cast concrete lintels, sills and water table pieces are spalled or cracked requiring replacement. The exterior wood sash windows are single glazed, in poor condition, are energy inefficient and need replacement. The metal coping high at the perimeter of the original building is rusted, peeling, and has holes in it in some locations. This metal coping needs repair, appropriate prep and re-painting. Exterior doors have either single pane glazing or are in poor condition and should be replaced along with the windows to match.

Classroom 1 windows

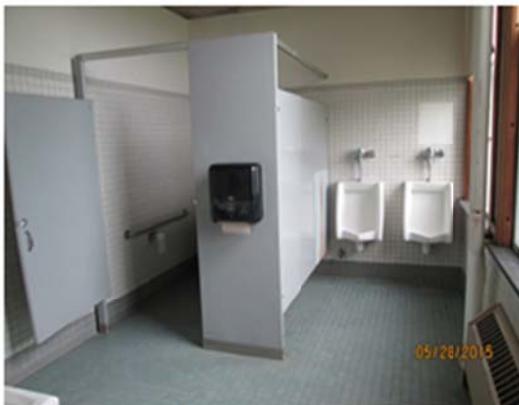
Although much of the interior finishes are in decent condition, a renovation of any kind would likely require new wall, ceiling, and floor finishes throughout. Since the new building use and layout are not available it is not possible to specifically identify the extent and type of finishes. The toilet rooms which have been modernized on each floor are in generally good condition although some fixtures are missing and some have water stained ceiling tile presumably from water leaking from toilet rooms above. Generally however these toilet rooms are serviceable once these specific issues are addressed.

Men's room

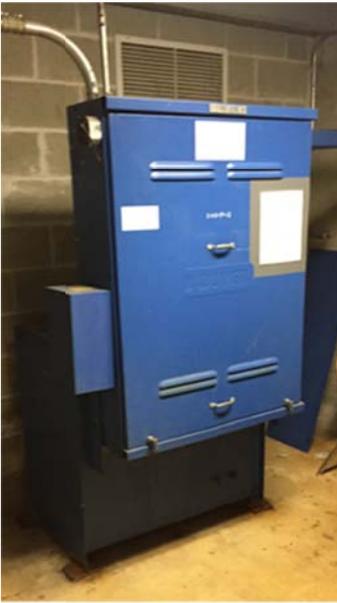
Since the building addition included a new elevator, all floor areas of the building are wheelchair accessible. The hydraulic elevator, manufactured by Dover, was installed in 1986. The elevator has a 2,500 lb capacity and has 4 landings (3 in front and one in rear). The mechanical equipment and cab appear to be in good condition and is ADA accessible. The elevator controller may require upgrading in the future renovation.

Hydraulic Elevator

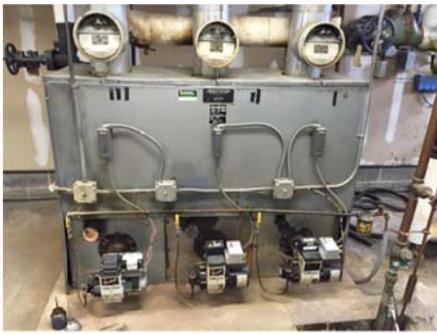
Heat is provided for the school by three oil fired modular hot water boilers. The boilers are manufactured by Hydortherm and are 909 MBH in capacity each. The boilers are over 25 years old, in fair condition and are controlled locally by a Johnson Controls electronic controller that start/stops the boiler and resets heating hot water temperature with outside air temperature. There are four 275 gallon oil tanks that provide #2 light oil for the boilers. The oil tanks are old but in fair condition and require an oil dam to prevent spilled oil from reaching a sump pump. Heating hot water is distributed throughout the building by a small centrifugal pump. Heating and ventilation air for the classrooms is provided by unit ventilators through the outside walls. Other spaces are provided heat by finned tube radiation. The unit ventilators and finned tube radiation are controlled by local electric thermostats and electric hot water heating valves. The classroom exhaust/relief air is ventilated by a combination of gravity and mechanical exhaust fans connected to exhaust shafts that exhaust through rooftop chimneys. A large shaft opening in each classroom provides exhaust/relief and manual damper exists in each classroom to vary the exhaust/relief air going into the relief/exhaust shaft. The bathroom exhaust is from centralized roof mounted exhaust fans. All controls are local and there is no centralized building automation system. The building is not air conditioned. The HVAC system is beyond its life expectancy, is in fair to poor condition, and will require replacement to meet current ventilation and fire codes and the future building needs.

Hot Water Boilers

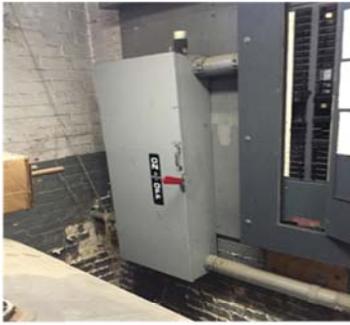
Main Fused Disconnect

Main electric is provided by an overhead electric service from an electric pole on Main Street and enters the building in the front on the northeast corner. The electric service is 400 amp three phase 120/208 volt. The main electrical equipment is located in the boiler room. A 400 amp fused main disconnect feeds the main distribution panel which is a GE 400 amp 120/208 volt 3 phase 4 wire panel. The main distribution panel is older and in poor condition with missing breakers/knockout covers and electrical/duct tape. The individual floors are served by newer GE 125 amp 120/208 3 phase 4 wire panel boards that were possibly installed during the mid-1980's elevator tower addition. There is evidence of old branch circuitry wiring and old abandoned electrical panels that are being used as junction boxes. The classrooms have limited electrical outlets and an electrical upgrade will likely be required to serve the future use of the building.

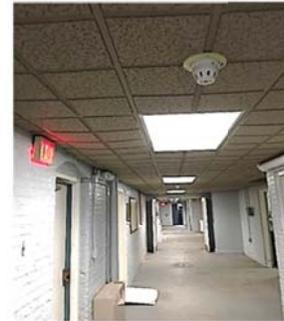
Hall Exit Sign & Light

Lighting throughout the building is fluorescent 4 foot T-8 fixtures with electronic ballasts. There is a combination of pendant style fixtures and 2X4 recessed fixtures in the classrooms and hallways. The exit signs are compact fluorescent. The lighting is generally in good condition with some older lighting fixtures in selected areas. However in a major renovation it is likely all lighting would be replaced along with updated interior finishes.

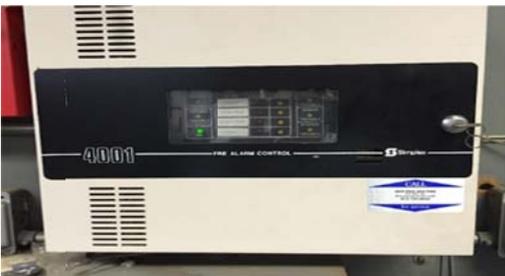
Fire Alarm Panel

The building has a Simplex 4001 fire alarm system that was likely installed in 1986 with the elevator tower addition. The fire alarm system has smoke detectors, some heat detection, audible alarms and pull stations throughout the building. The fire alarm is non-addressable and has a zone per floor and will require a replacement and upgrade depending upon future building use. The building has a Simplex 2350 master time system which is obsolete and no longer manufactured. Communications

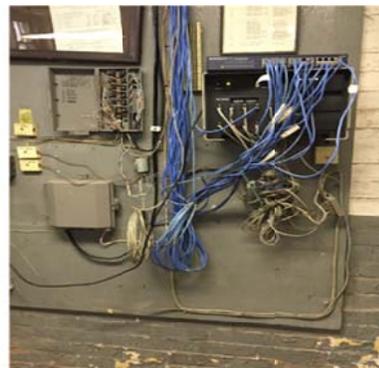
Tele/Data Panels

cabling enters the building on the southwest corner and is fed from a pole on South Street. The tele/data system is in fair to poor condition and will require upgrading.

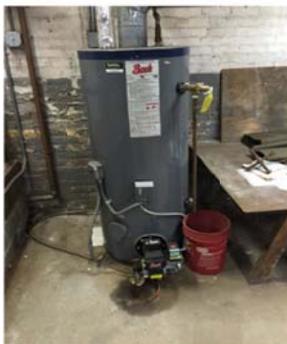
Water Service

The plumbing fixtures appear to be in good condition; however some plumbing fixtures have been removed, presumably for use elsewhere when the school closed. The water service enters the building from South Street and the building is served by a 2 inch water meter. The water piping is copper and appears to be in fair condition. The building sanitary piping system appears to have leaked and been repaired in several locations and will need to be replaced and likely reconfigured depending upon the future usage of the building. Domestic hot water is provided by a Brock oil fired water heater with 50 gallons of storage. The domestic hot water system includes a 3-way mixing valve to temper the water and a re-circulating loop and small circulating pump. The domestic hot water heater is relatively new and in good condition.
